ORNL-1868

DISASSEMBLY AND POSTOPERATIVE EXAMINATION

OF THE AIRCRAFT REACTOR EXPERIMENT

AIRCRAFT REACTOR ENGINEERING DIVISION
DISASSEMBLY AND POSTOPERATIVE EXAMINATION
OF THE AIRCRAFT REACTOR EXPERIMENT

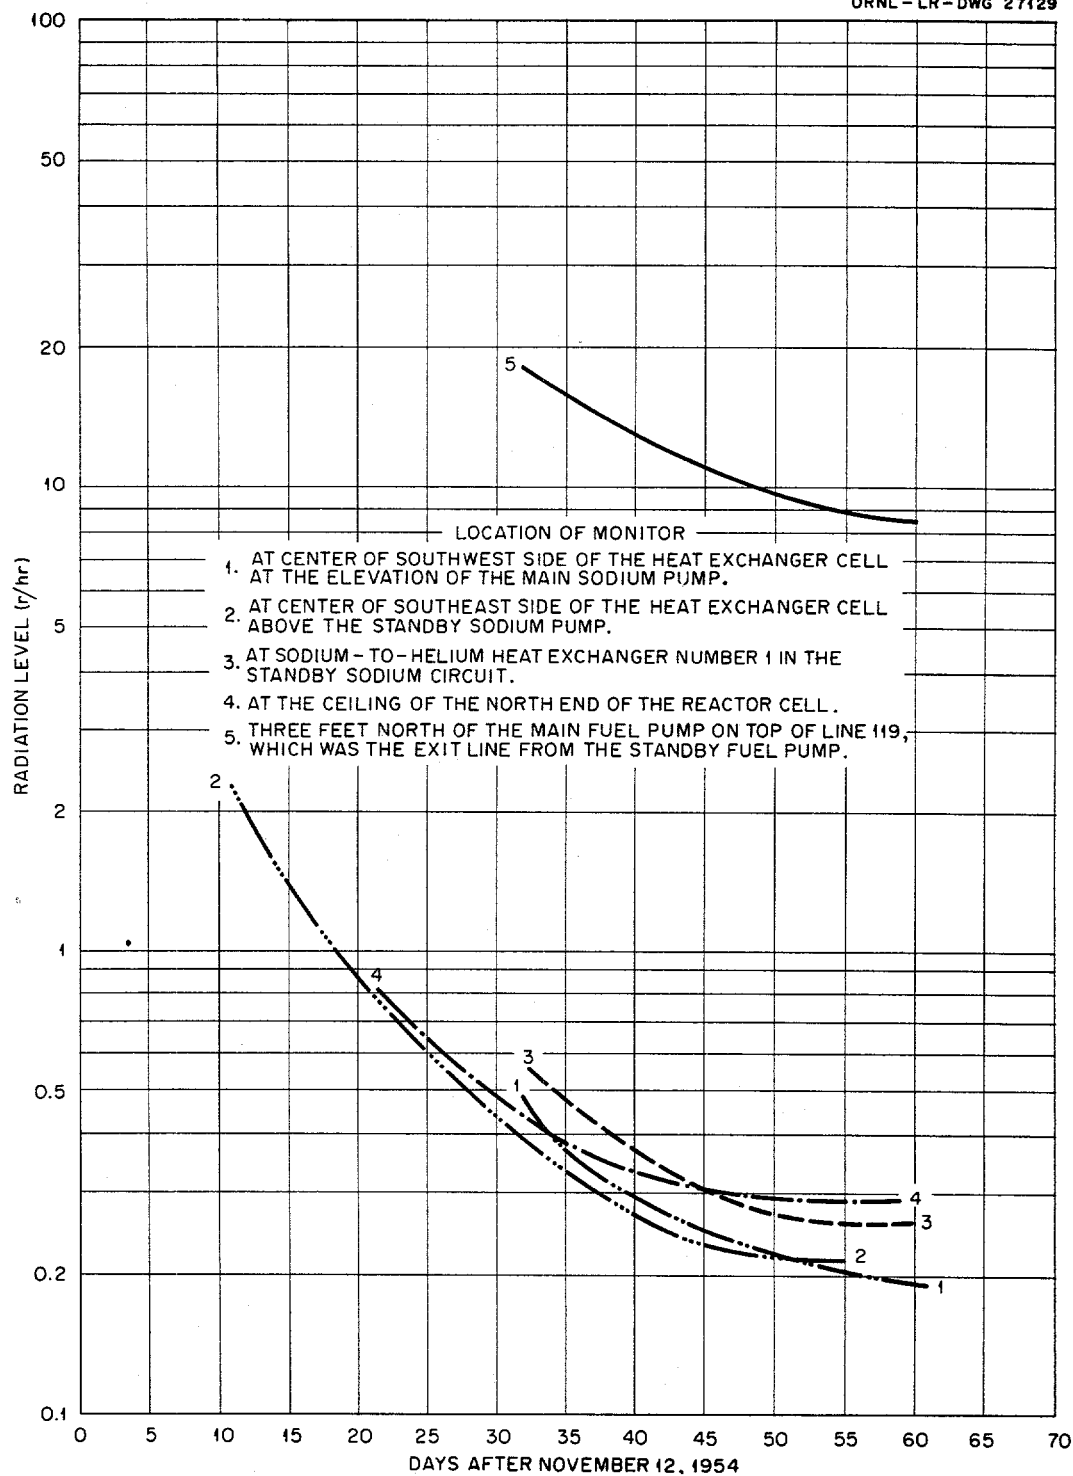
Fig. 4. Radiation Decay Curves for Five Locations in ARE System.

Radiation surveys were used as a basis for planning the disassembly sequence and techniques. The radiation decay curves obtained from data taken daily at five monitoring points are shown in Fig. 4.

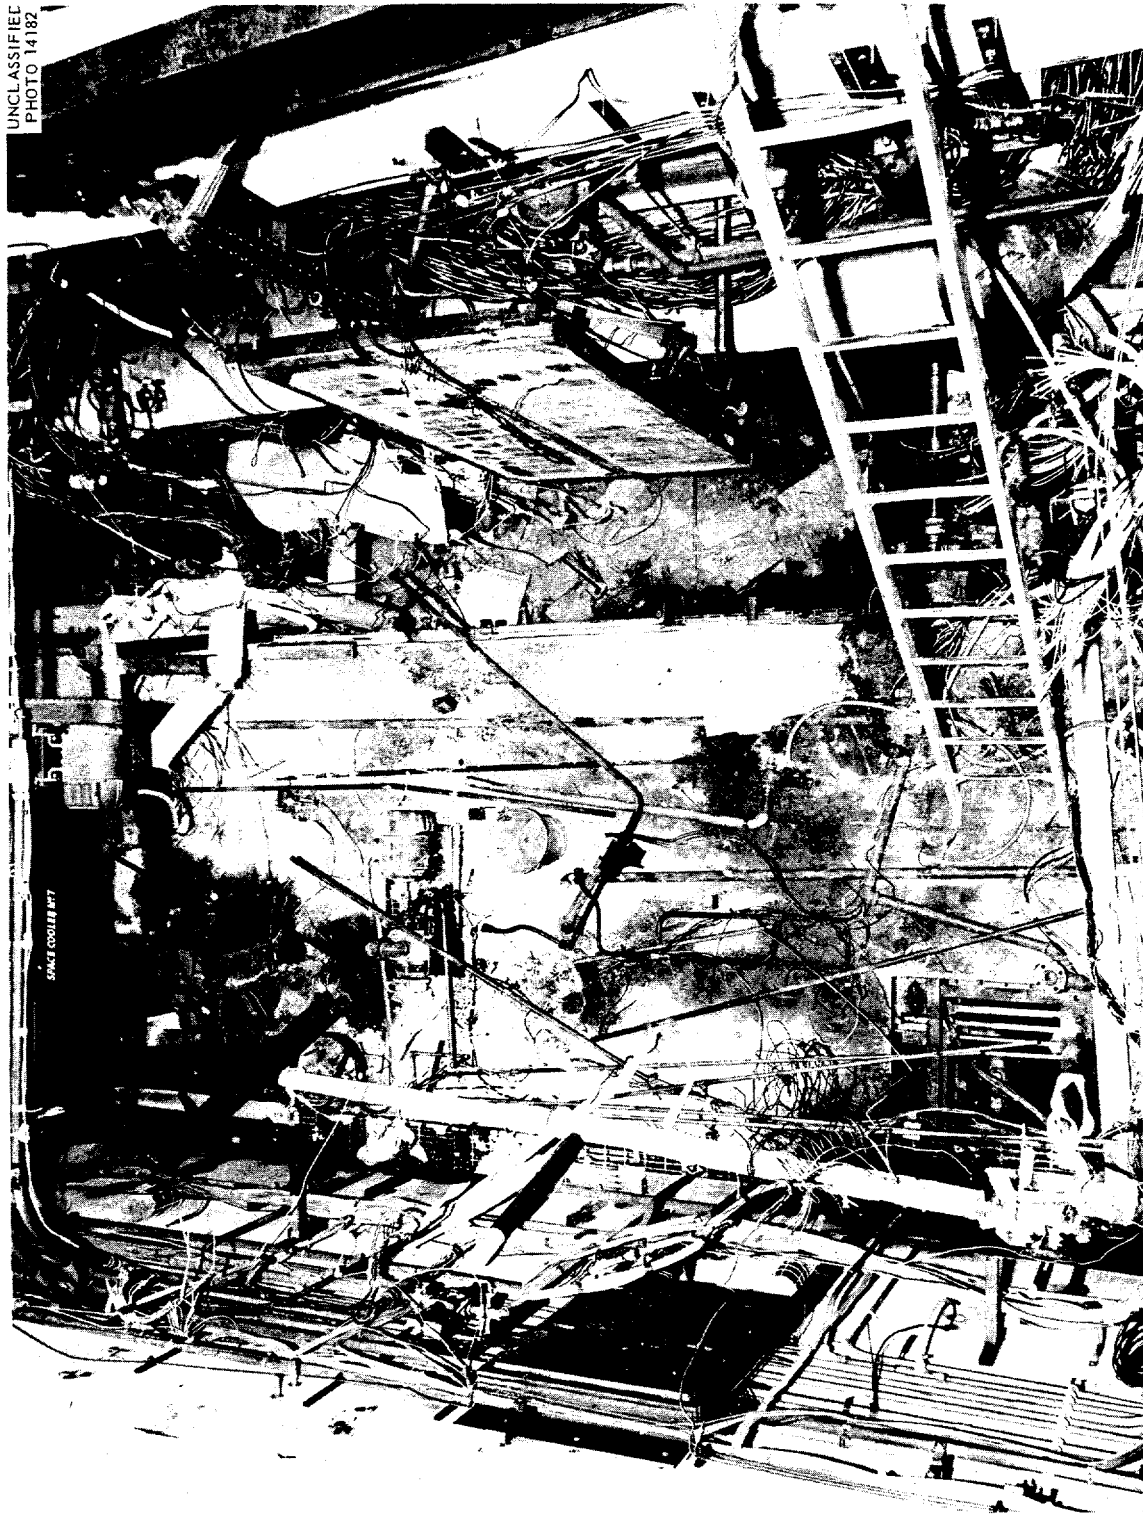
Fig. 5. Heat Exchanger Pit After Removal of Sodium System Pumps and Heat Exchangers and Lines. Note lead shield used to protect workers from fuel system radiation.

After the removal of the sodium system pumps and heat exchangers, it was found that the radiation field had increased to about 600 mr/hr. The equipment had helped to shield the area from the fuel system radiation.

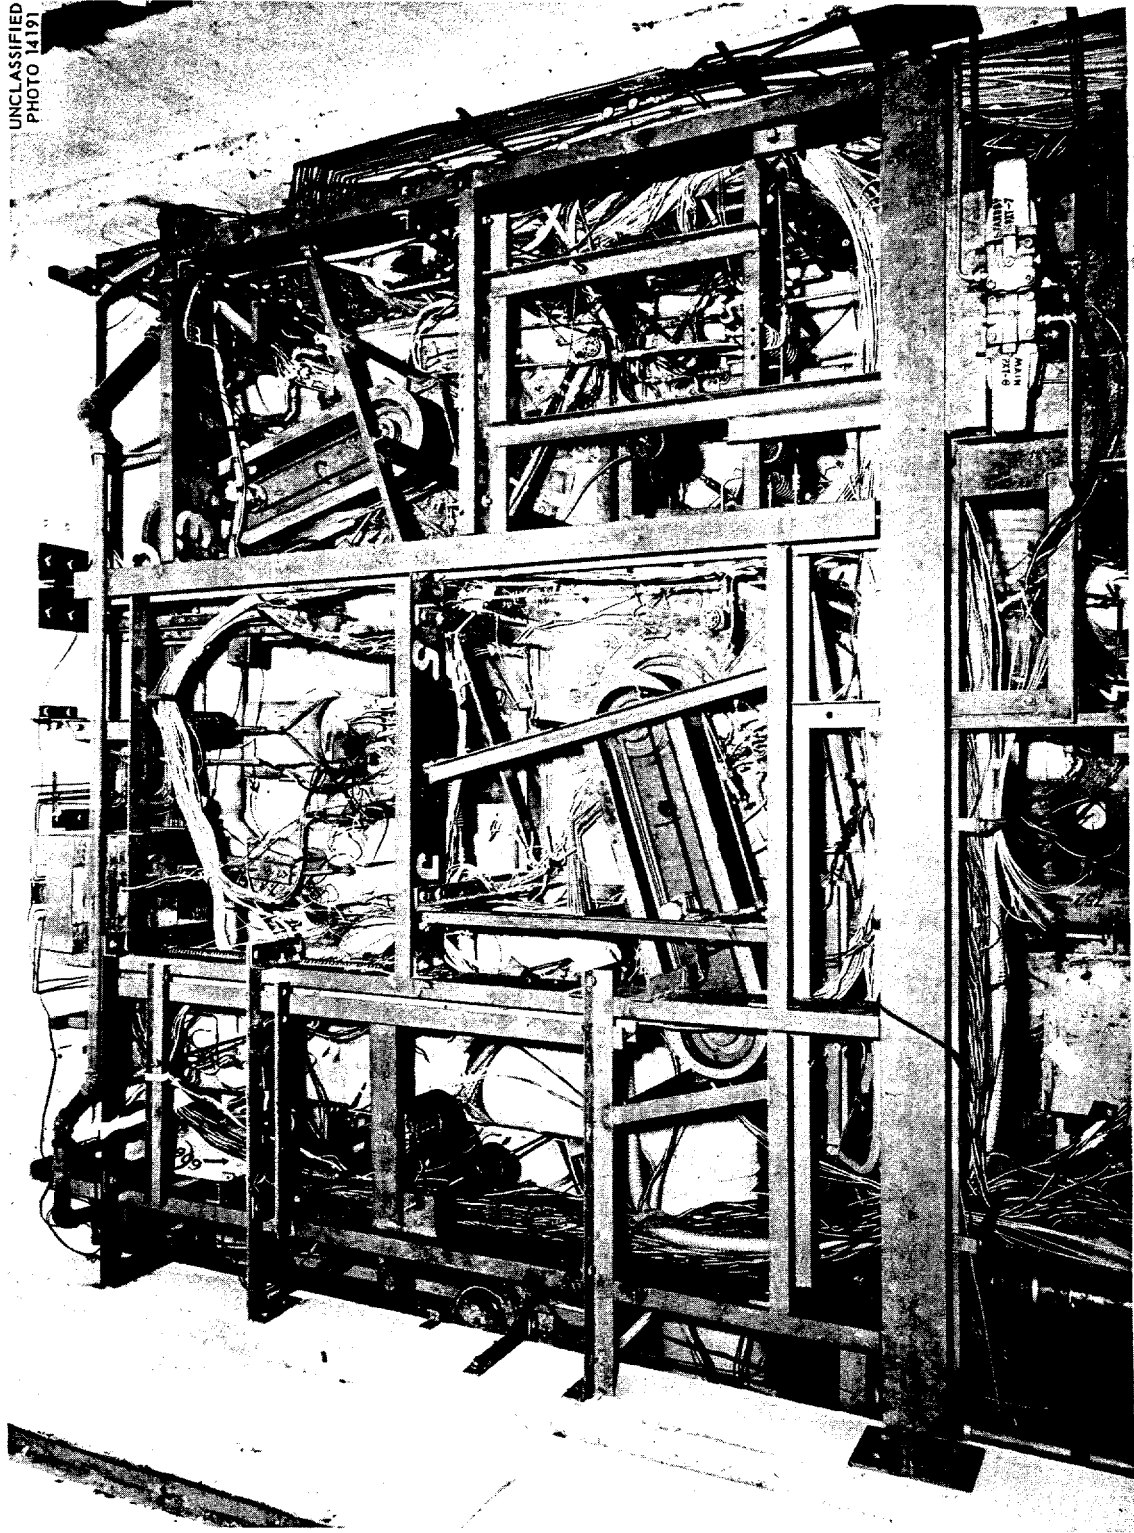
Fig. 6. Heat Exchanger Pit Showing Components of Fuel System Before Dismantling Operation.

The components of the fuel system are illustrated in Fig. 1, and a photograph of the cell containing the fuel pumps is presented in Fig. 6. The disassembly work was started with the main fuel pump which was causing a high radiation field. Removal of the rotary assembly caused a small burst of air activity that cleared in 2 to 3 min. The radiation level of the rotary assembly was 20 r/hr at 5 ft. After removal of the rotary assembly, the lines to the pump were cut and sealed and the pump was lifted out of the cell, as shown in Fig. 7. The radiation level of the main fuel pump bowl was 900 mr/hr at 5 ft. The standby fuel pump was removed in a similar manner. This pump was not used during

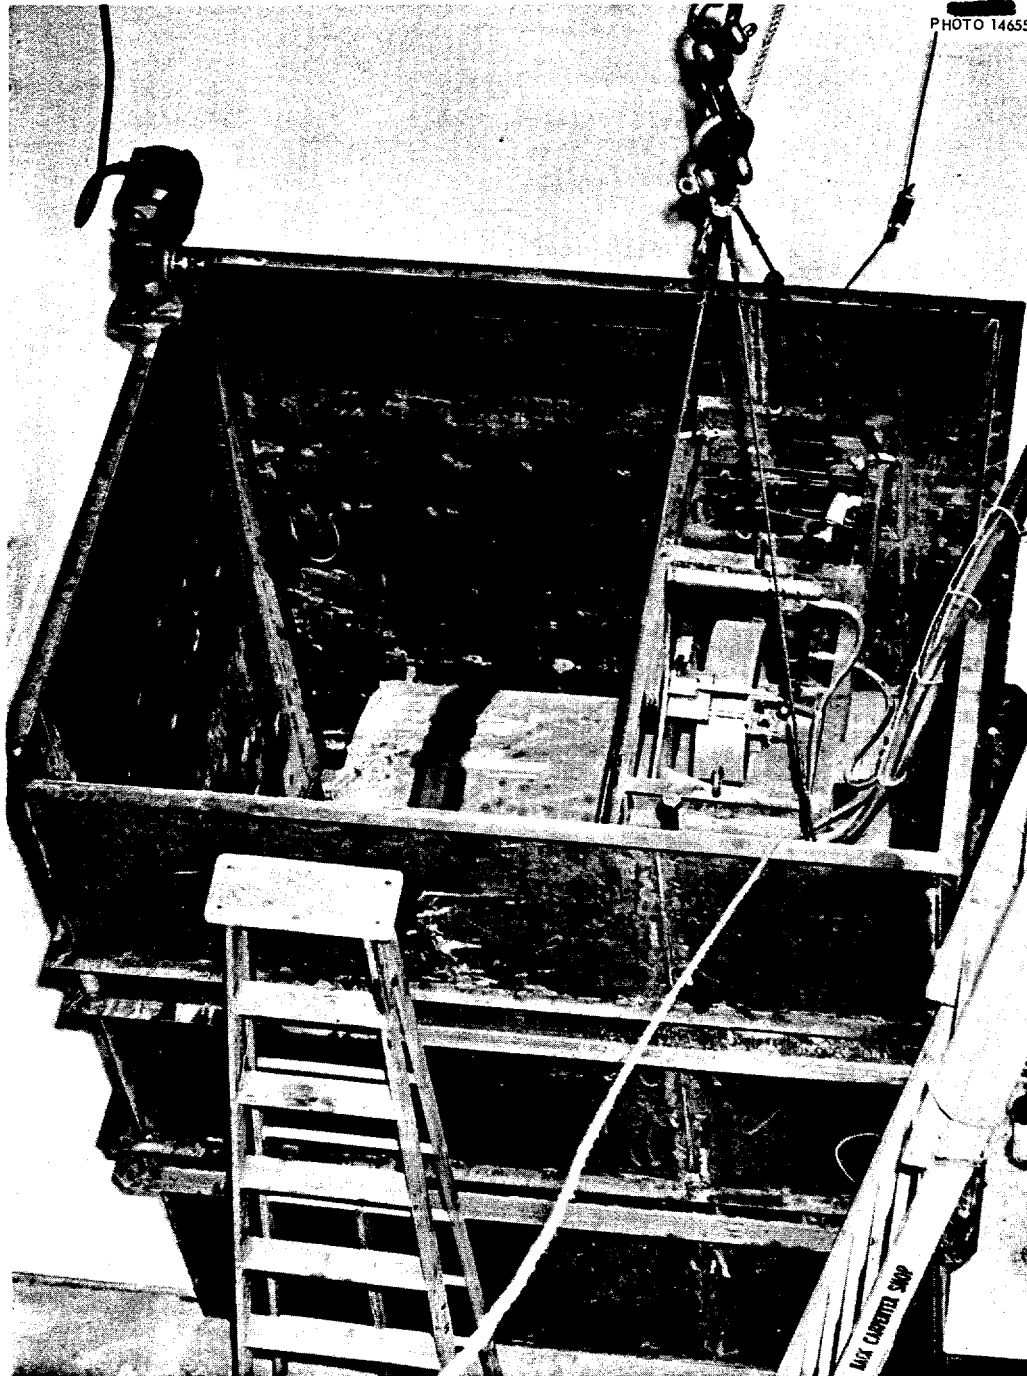
Fig. 10. Reactor Positioned in Disassembly Tank for Grinding.

is shown in Fig. 10 positioned in the tank for grinding, and the cutting side of the grinder, which was designed to be used under liquid, is shown in Fig. 11. With this equipment, a period of five 8-hr days was required to cut the 2-in.-thick pressure shell. Upon removal of the shell, a radiation check was made. The

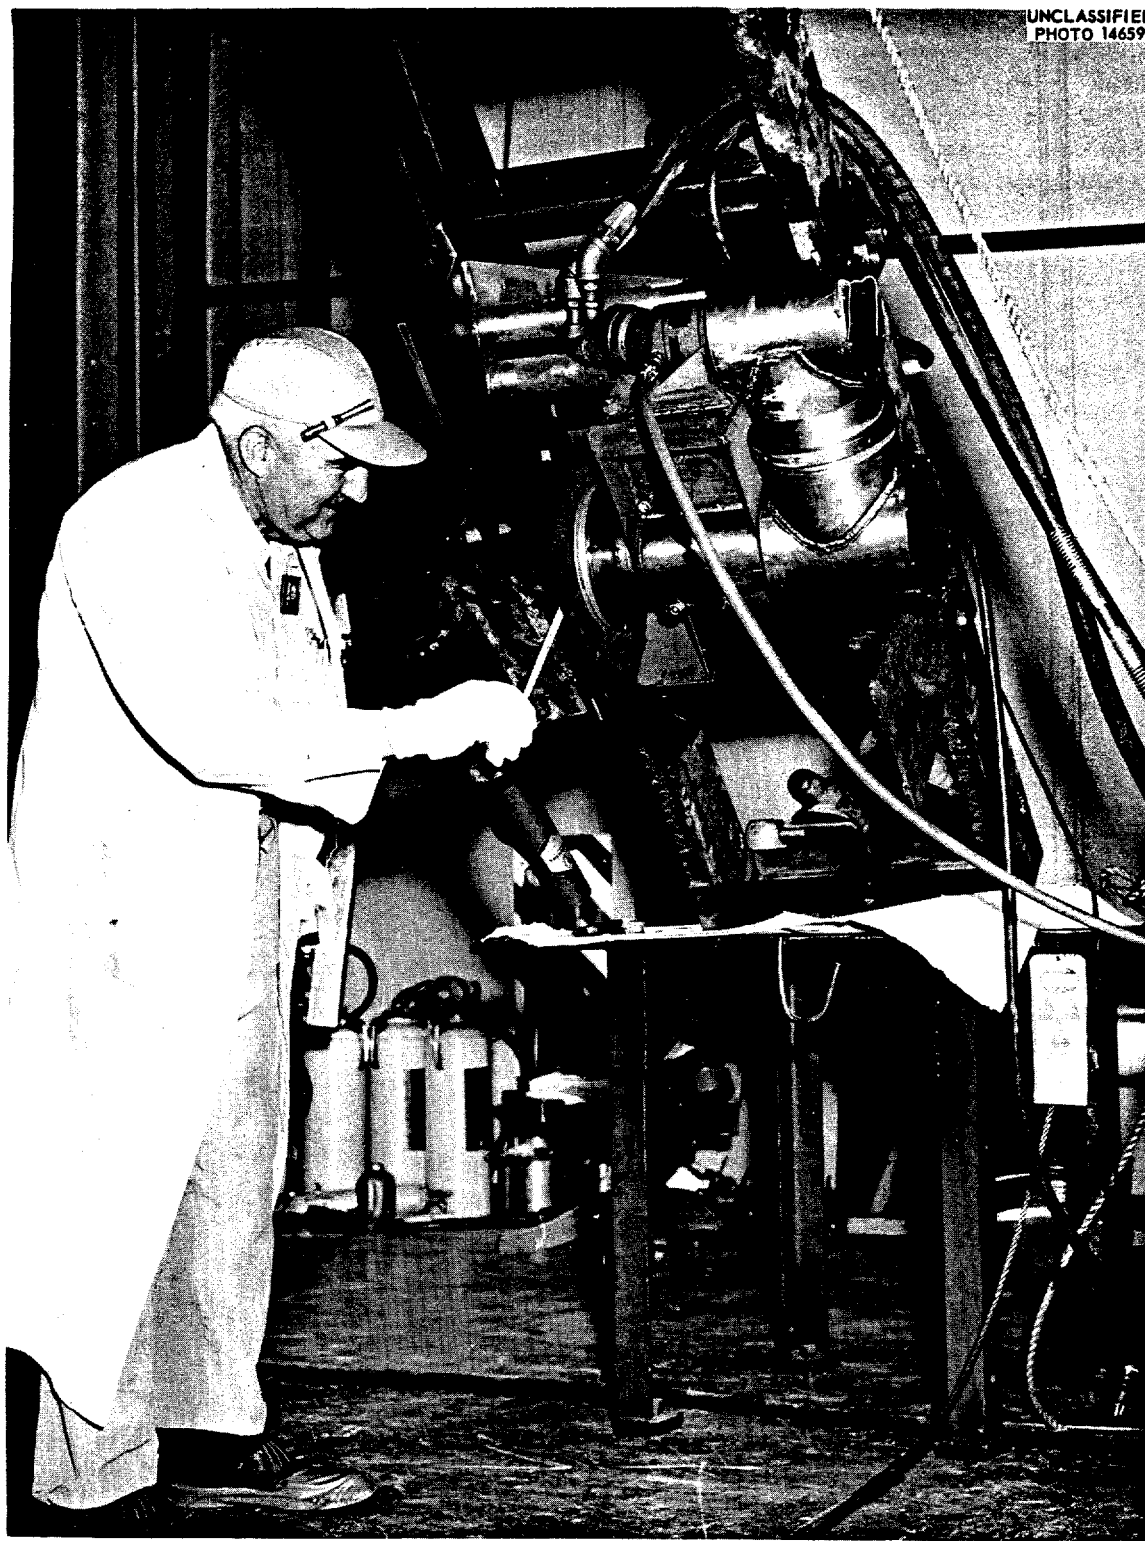
Fig. 11. Cutting Side of Grinder for Dismantling the Reactor.

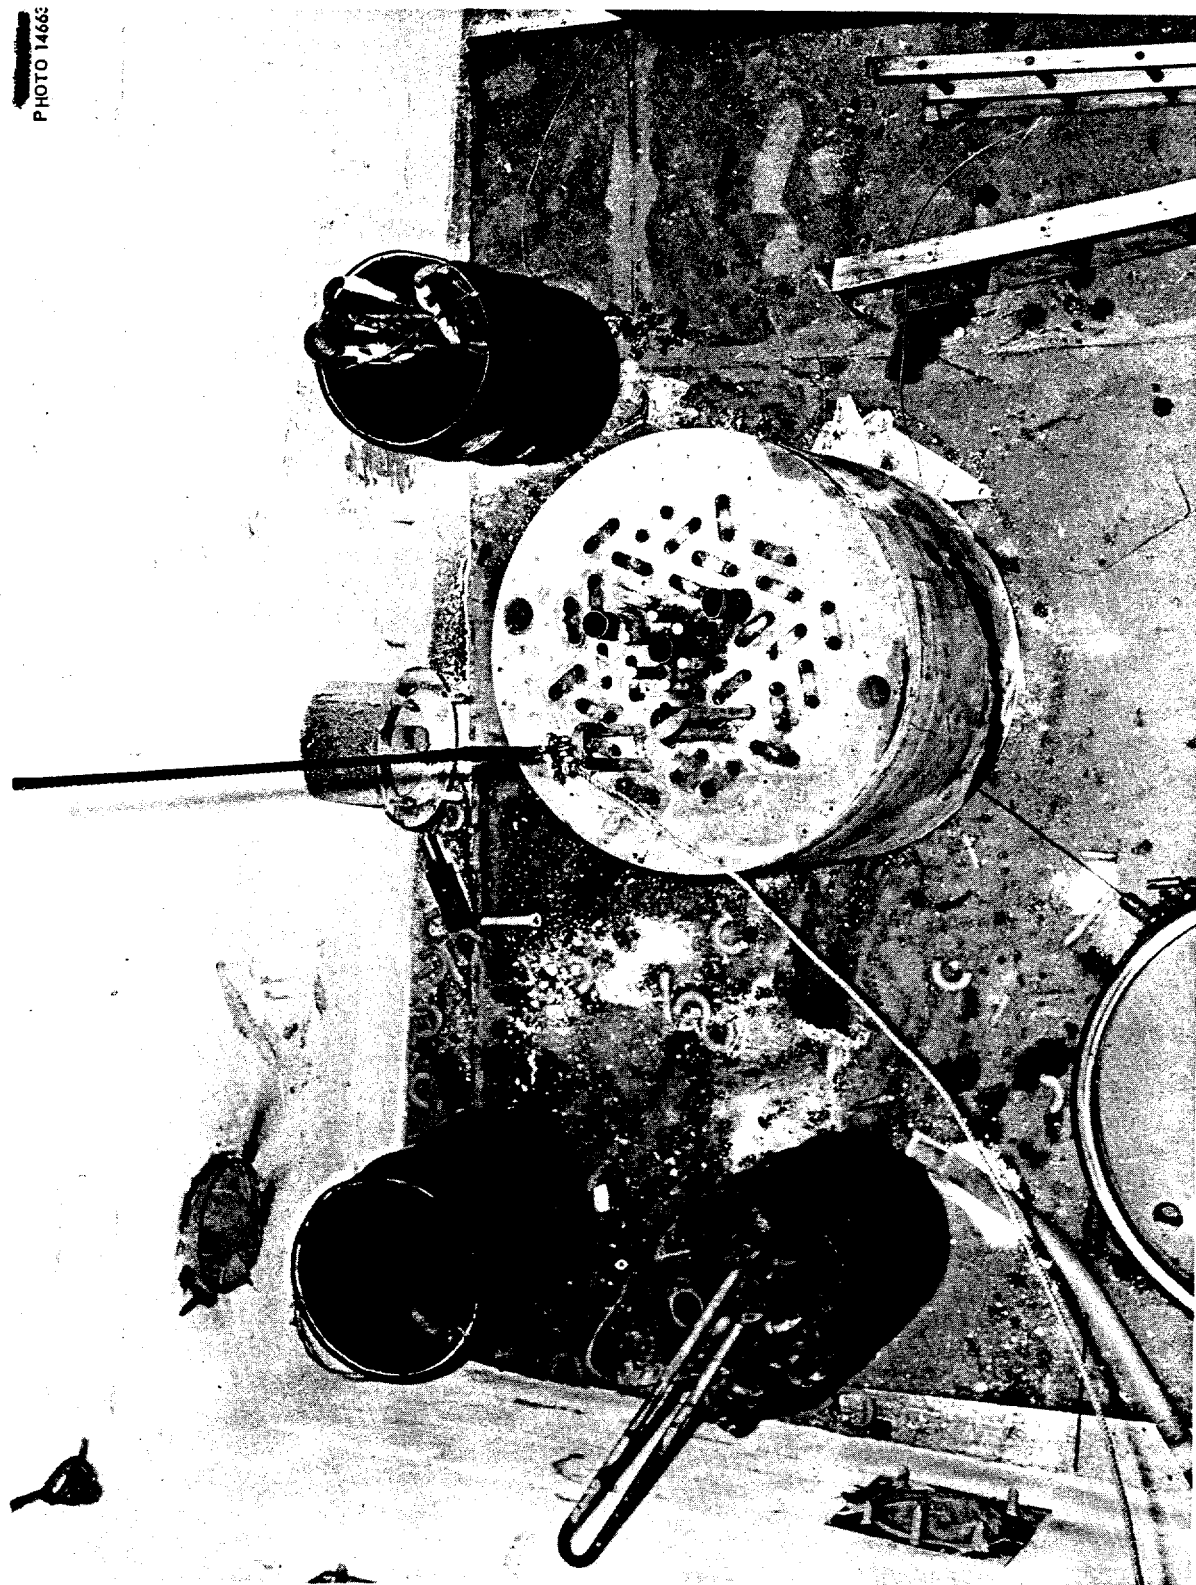
Fig. 12. Top of Reactor After Removal of Pressure Shell and Some of the Sodium and Fuel Tubes.

The next task was the removal of fuel tubes and samples of the BeO moderator blocks. The fuel tubes and the BeO blocks were encased in a stainless steel can with welded seams, shown in Fig. 12, and the small sodium tubes

that penetrated the BeO blocks were welded to the top and bottom of the can. In order to free the top of the can, the welds holding the sodium tubes were drilled out and the outer edge of the can was cut. The reactor was then placed in a horizontal position and the fuel tube bends were cut off flush with the bottom of the can. After removal of the bottom tube bends, the reactor was set upright and the crane was used to pull out the fuel tubes and to place them in drums, as shown in Fig. 12.

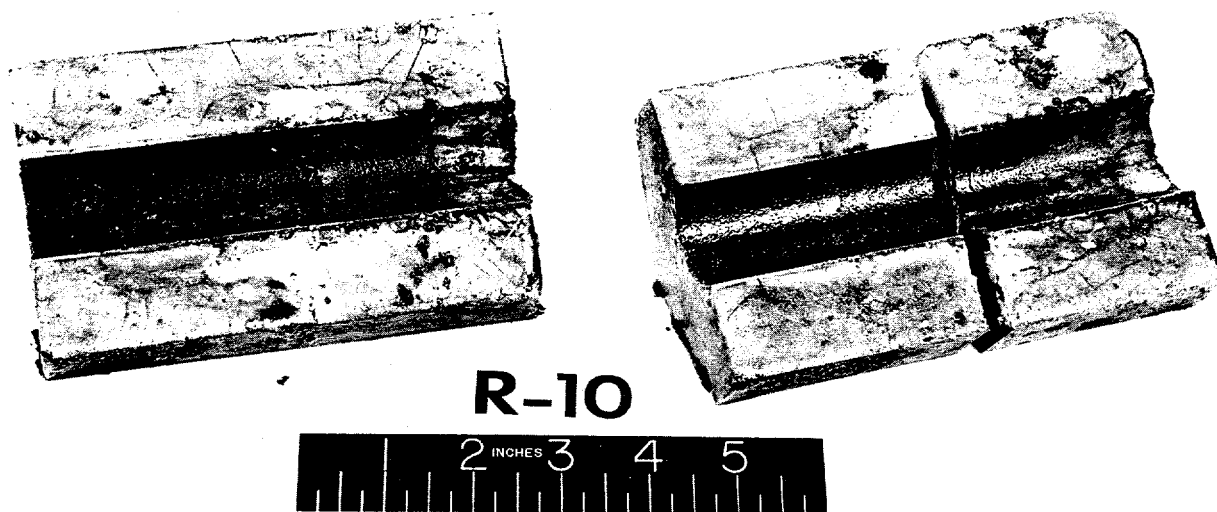
The block shown in Fig. 14, which had surrounded a fuel tube in the central region of the reactor, has many visible cracks and one half of the block had fractured. Previous tests of the as-received blocks had revealed that nearly all the blocks had at least one crack and some of the blocks had several cracks.³ Comparison with photographs of the as-received blocks showed that slight erosion of the edges occurred during reactor operation. The presence of small flakes of BeO adhering to the surface of the block indicated some spalling.

Fig. 14. BeO Block Which Had Surrounded a Fuel Tube in the Central Region of the Reactor.

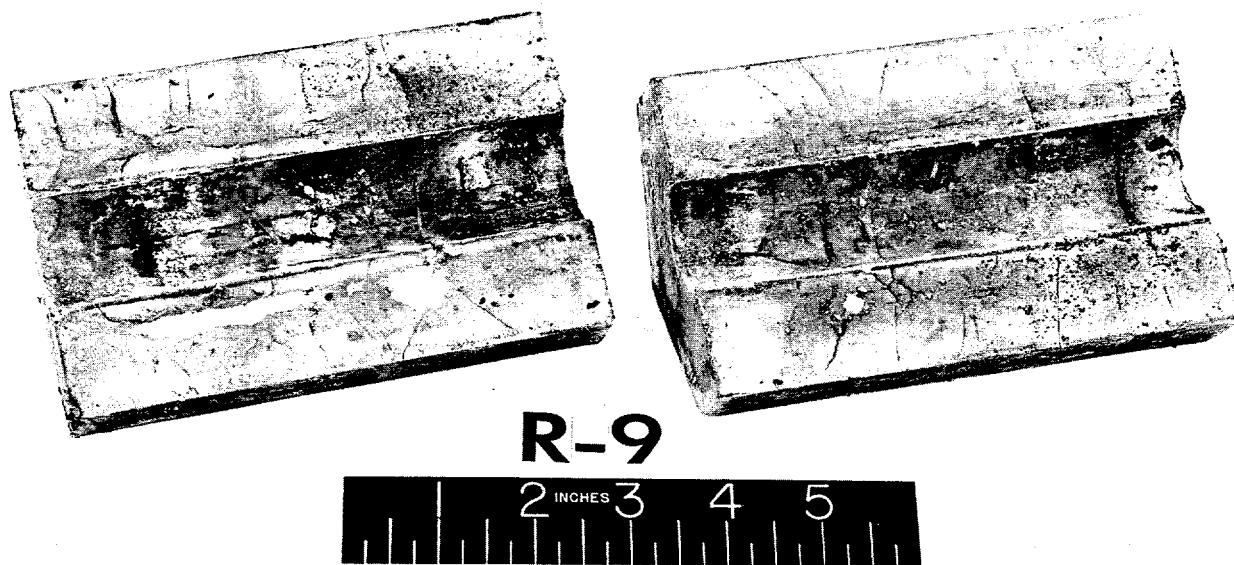
A BeO block that surrounded a fuel tube in the outer region of the reactor is shown in Fig. 15. The droplets visible on the surface are sodium hydroxide produced from sodium that remained after removal from the reactor. There were no complete fractures of this block, but many cracks are visible.

Fig. 15. BeO Block Which Had Surrounded a Fuel Tube in the Outer Region of the Reactor.

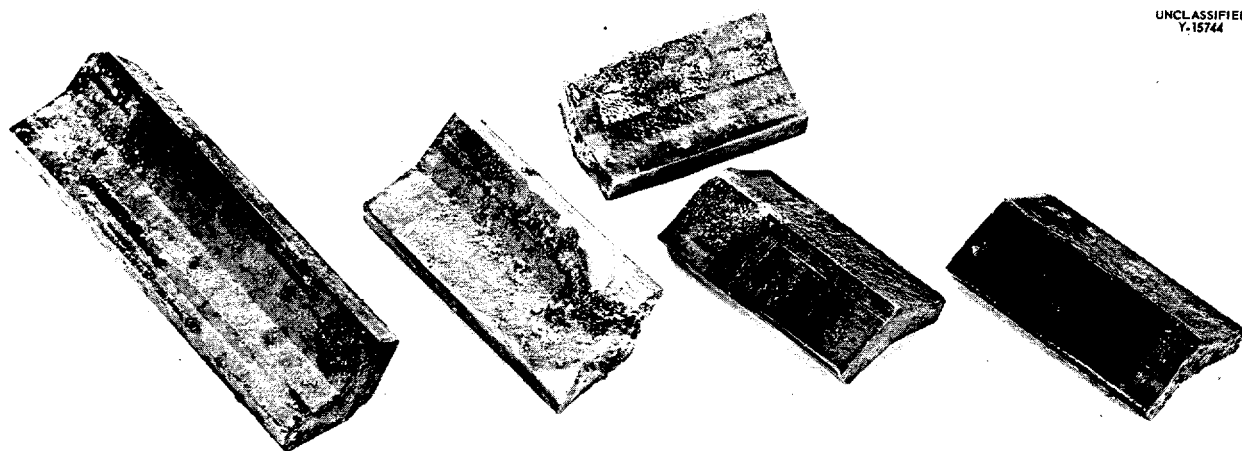
Three cut blocks from the core are shown in Fig. 16. Two of the three blocks fractured during operation of the ARE; however, no cracks are visible.

Fig. 16. Three Cut BeO Blocks from Reactor Core.

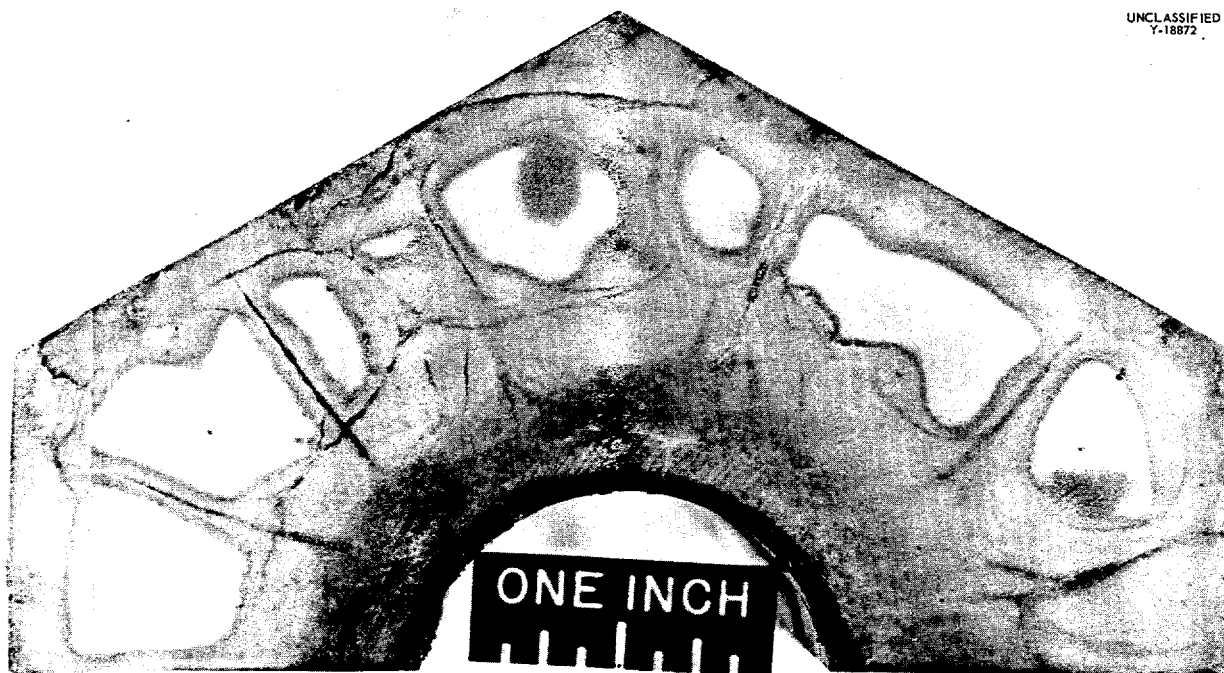
Only the BeO block taken from the outer region of the core (Fig. 15) was examined to determine the depth of penetration of the sodium. The dark areas in the transverse sections shown in Figs. 17 and 18 indicate high sodium concentrations in porous material, whereas the light areas, which were not penetrated by sodium, are dense material. The dark lines indicate sodium in cracks and crevices. As may be seen, the core of the block is more porous than the periphery. Cracks did not propagate through the dense material. In general, the BeO blocks withstood the operation of the ARE reasonably well.

Fig. 17. Transverse Section of Block Shown in Fig. 15.

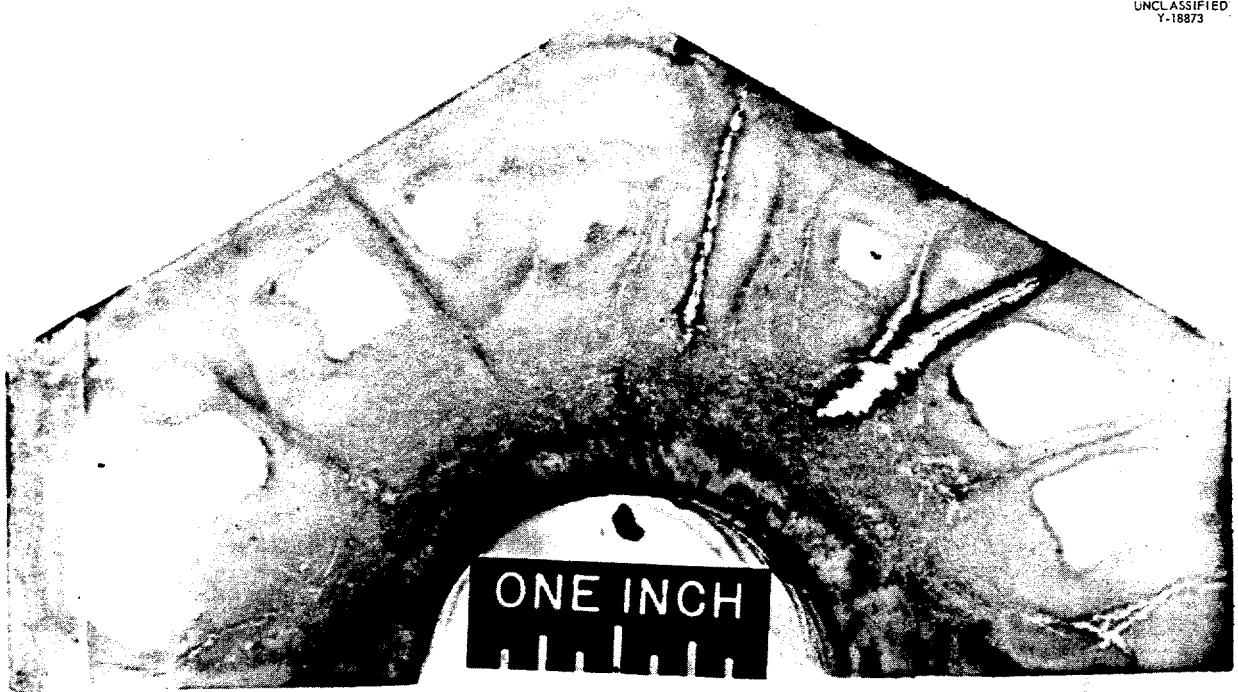
Fig. 18. Another Transverse Section of Block Shown in Fig. 15.

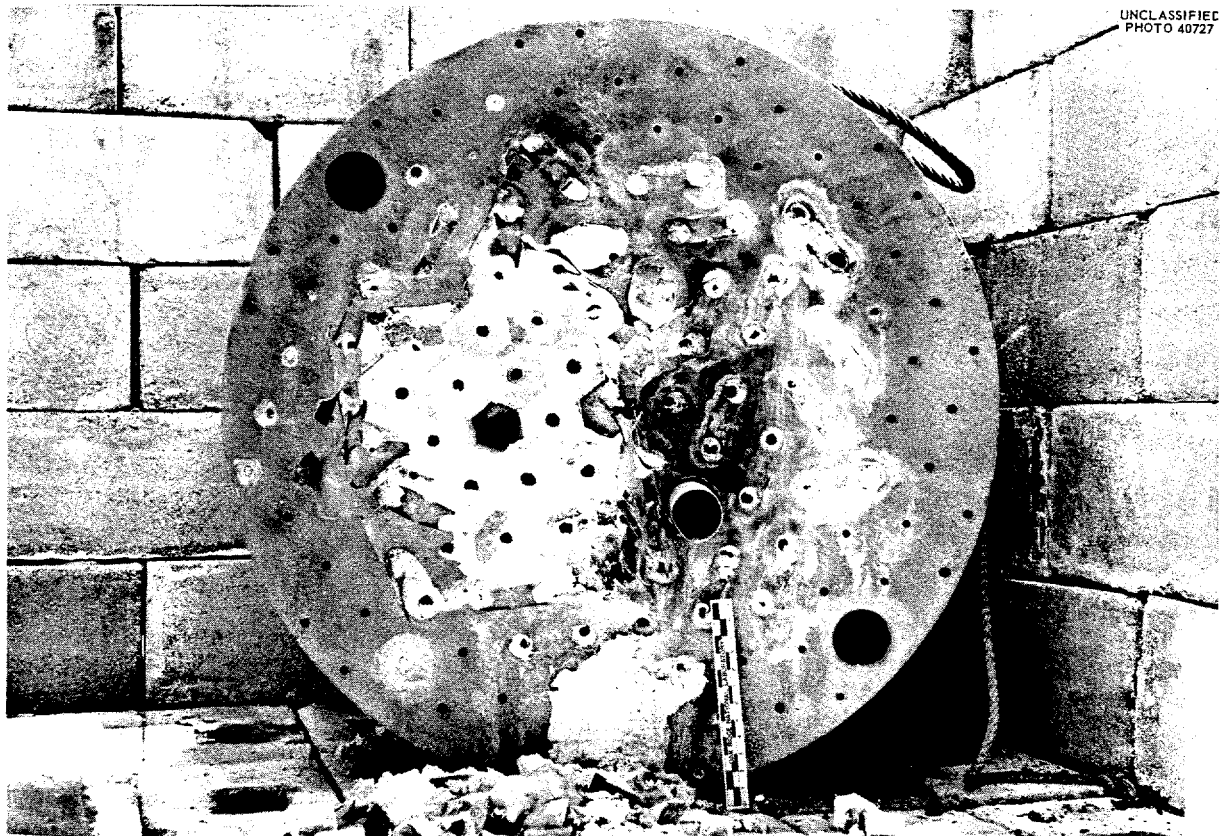
The remainder of the blocks were stored in place in the reactor. When final disposition of the reactor was to be made in October 1957, it was found that, as a result of atmospheric action on the adsorbed sodium, the blocks had deteriorated to the point where they had lost their structural strength. Since the blocks could serve no further useful purpose, they were buried along with the reactor. The results of attempts to remove blocks for examination prior to the disposal decision are shown in Figs. 19 and 20, and the reactor may be seen in Figs. 21, 22, and 23 just prior to burial.

Fig. 19. Condition of Reactor When Removed from Storage in October 1957. The broken pieces of BeO blocks on the floor resulted from attempts to remove blocks for examination.

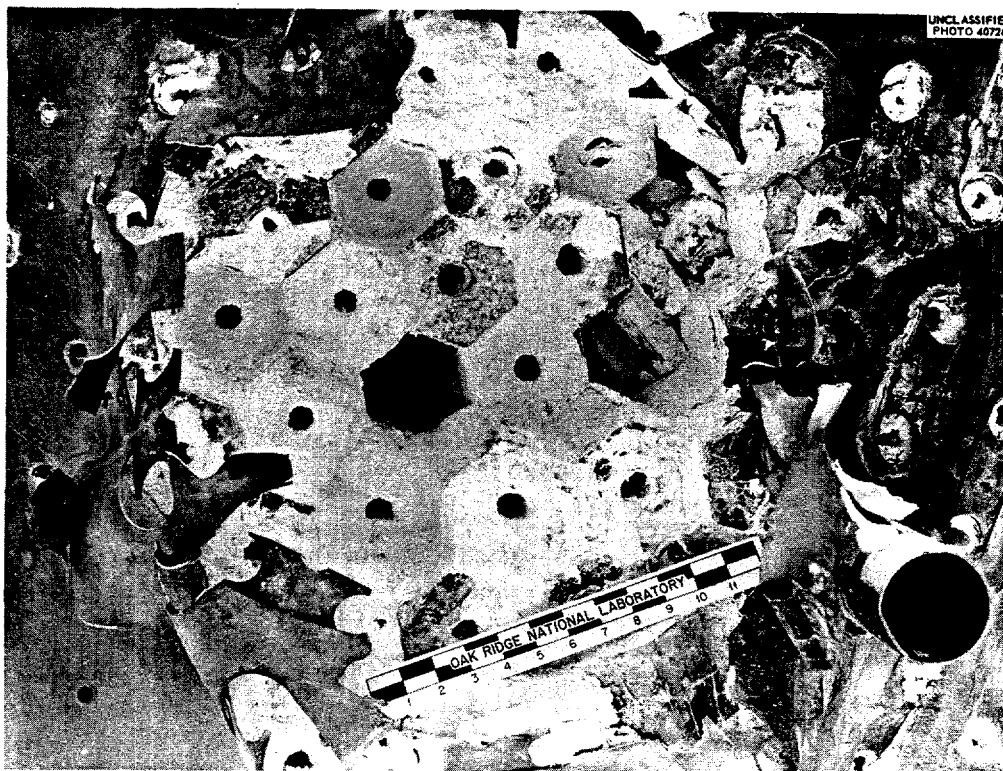
Fig. 20. View of Deteriorated BeO Blocks in Reactor.

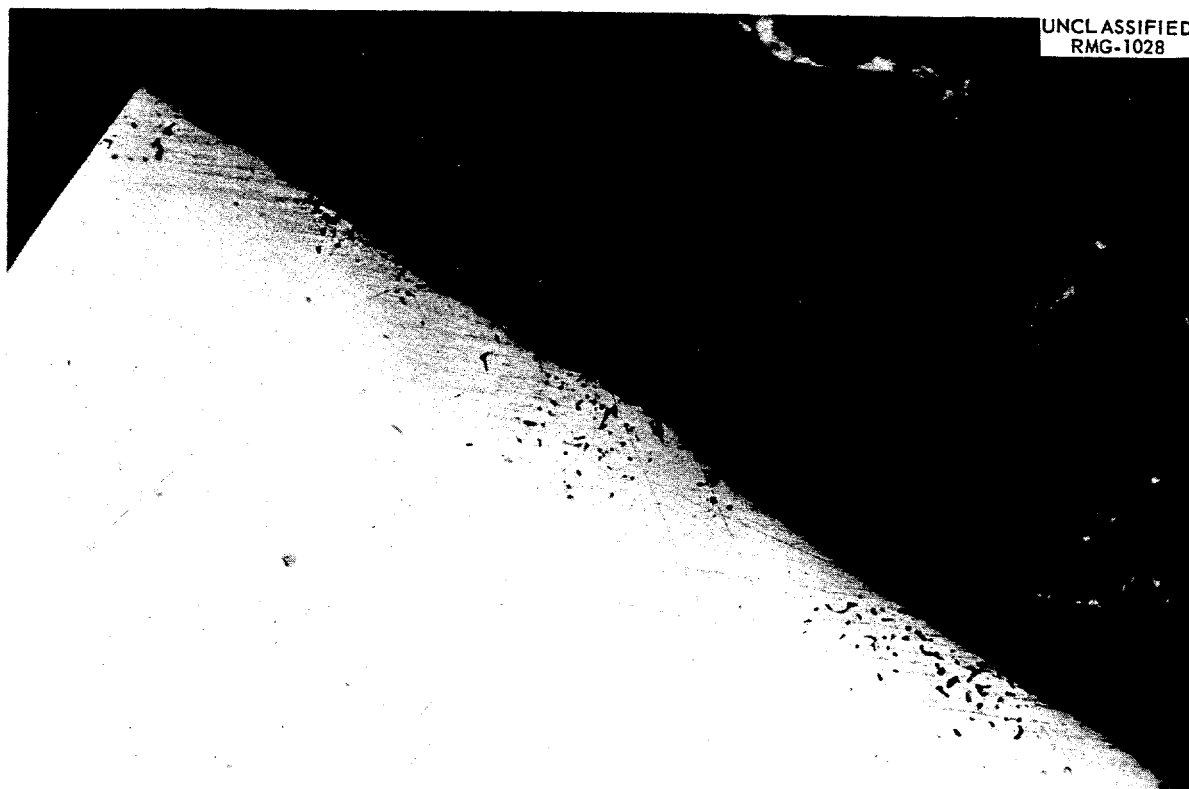
Specimen F1 from fuel supply line 120 was found⁴ to have general surface attack to a depth of 1 to 2 mils (Fig. 24), and the surface was rough, as shown in Figs. 25 and 26. Stereophotographs were taken of the seats and plungers from valves U-1 and U-23 (specimens F11, F12, S4, and S5).⁵ As shown in Figs. 27 and 28, there were dark deposits on the Stellite seat and plunger from valve U-1. The Stellite plunger from valve U-23 was scored, as shown in Fig. 29; the seat of valve U-23 is shown in Fig. 30.

Fig. 24. Inner Surface of Fuel Supply Line 120 (Specimen F1). Unetched. 250X.

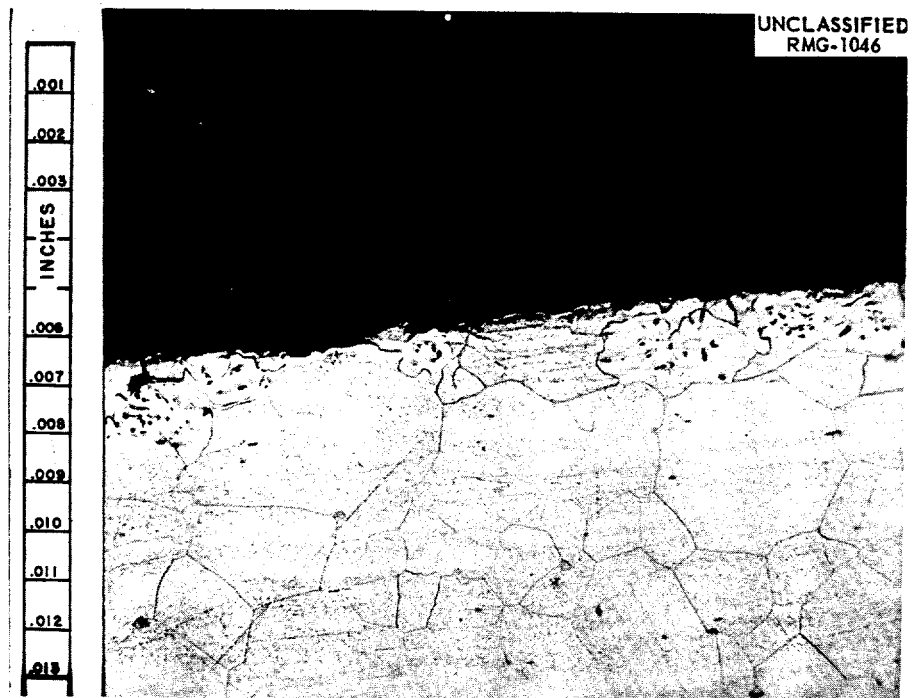
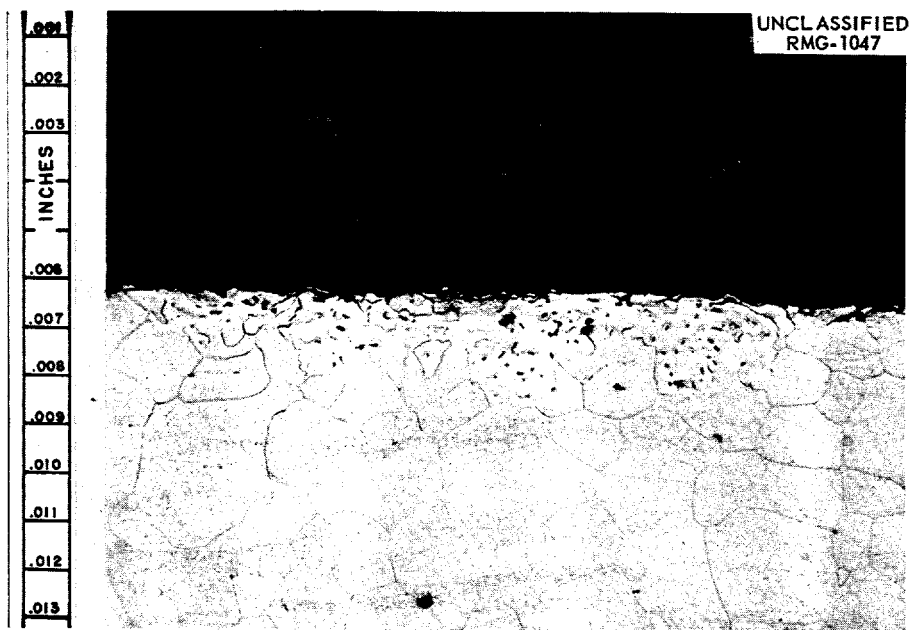
Fig. 25. Etched Section from Specimen F1. Etchant: electrolytic oxalic acid (10%). 250X.

Fig. 26. Another Section from Specimen F1. Etchant: electrolytic oxalic acid (10%). 250X.

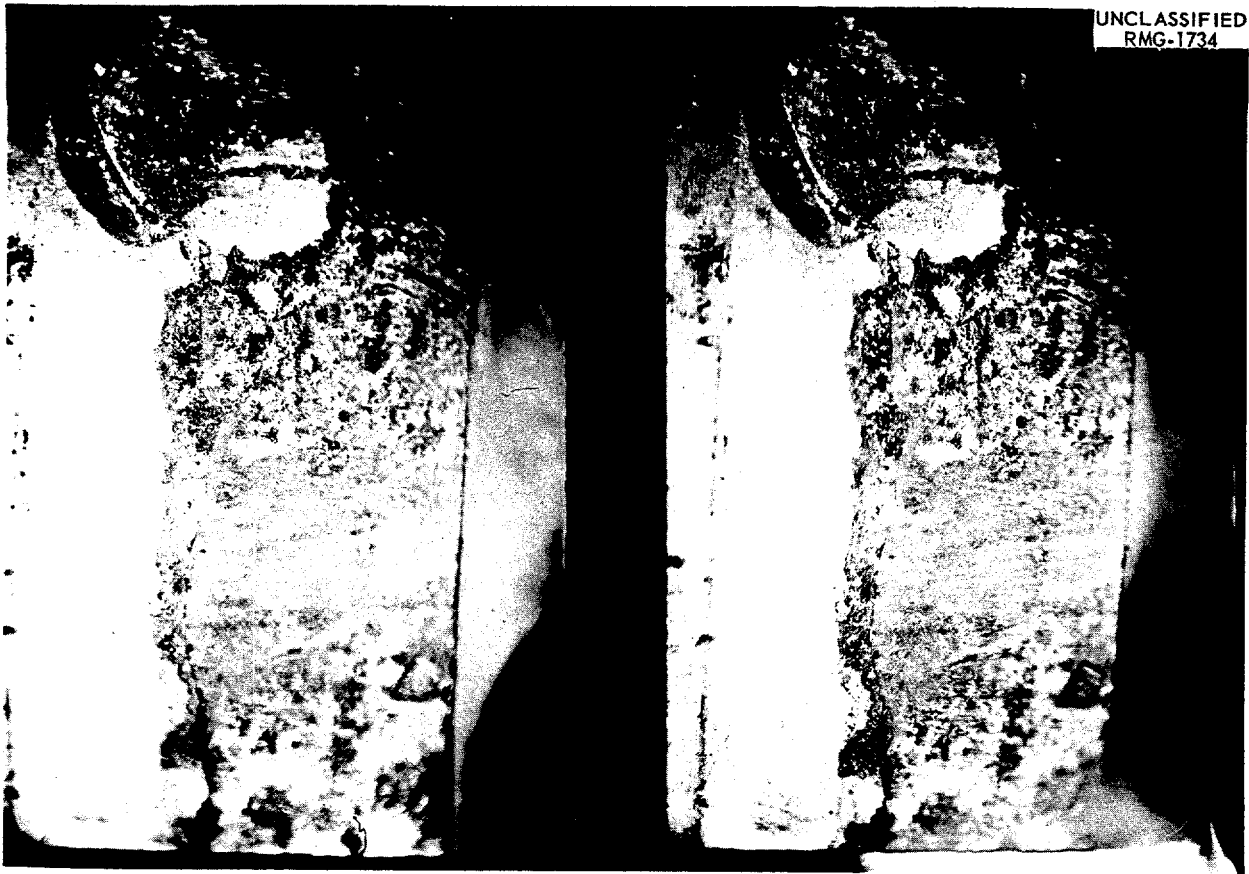
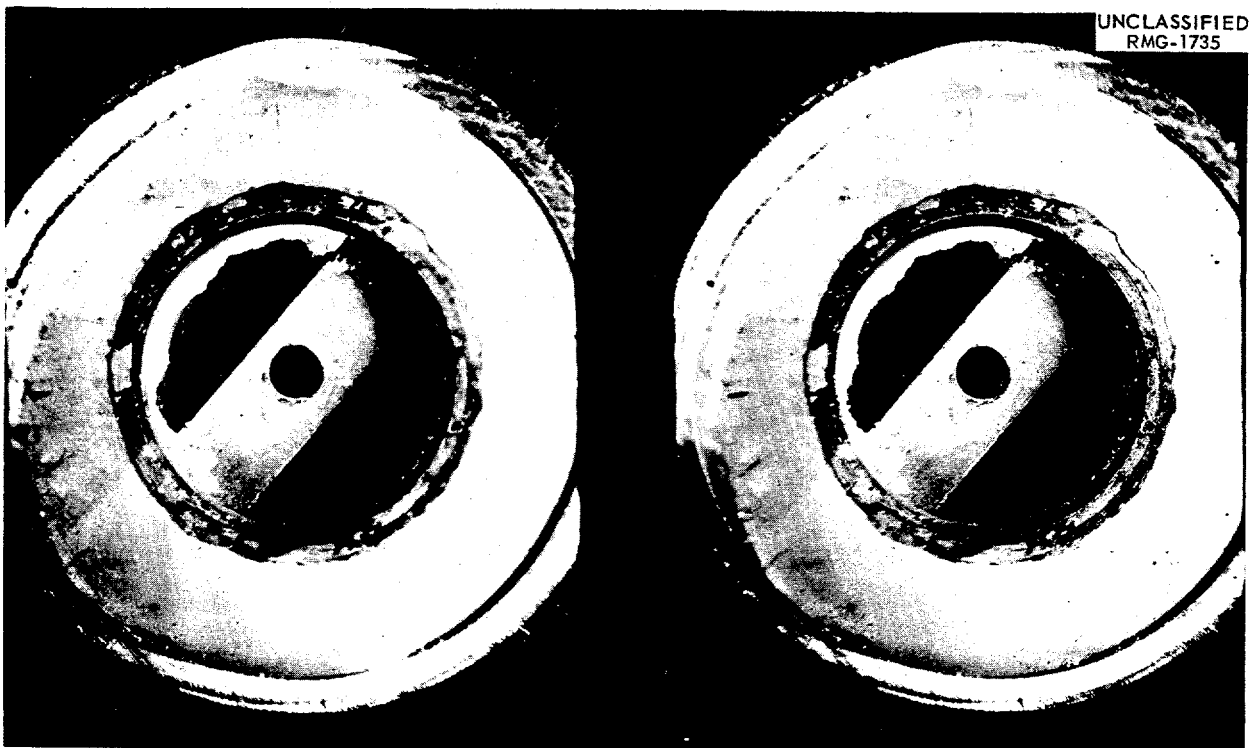
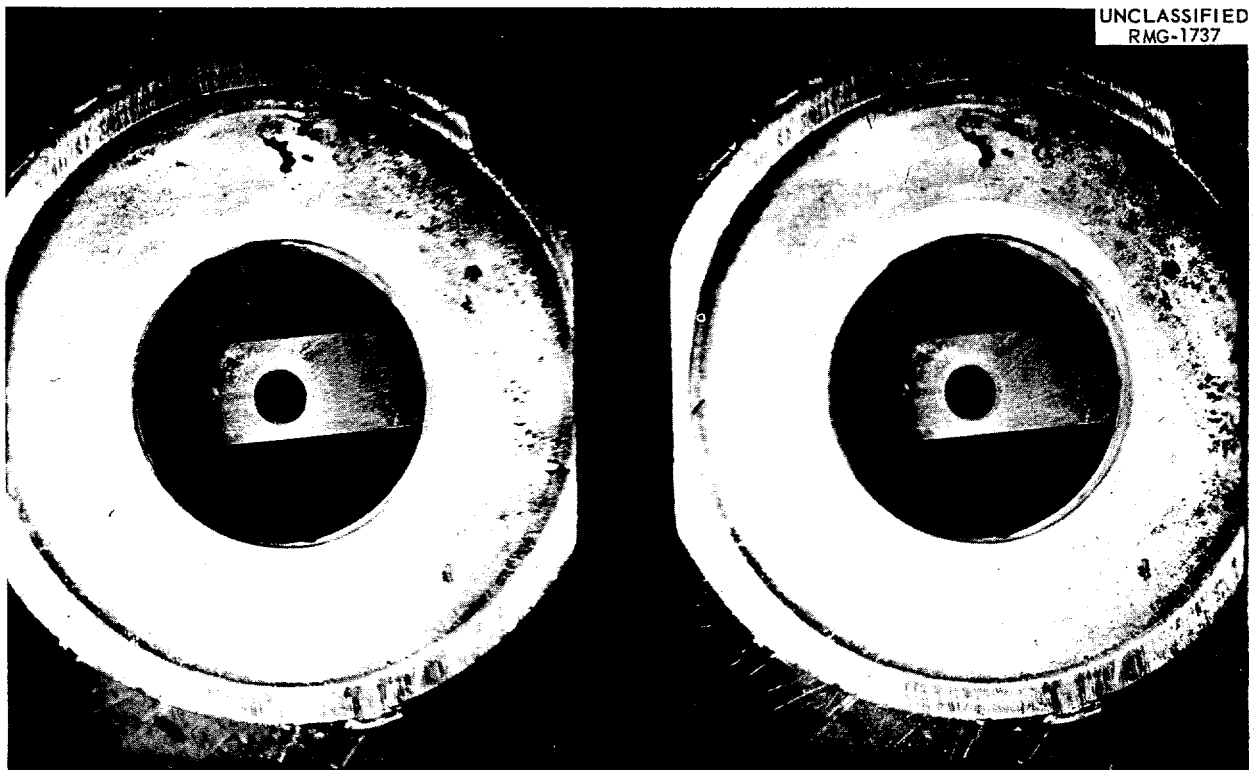
Fig. 27. Plunger from Valve U-1. 5X.

Fig. 28. Seat from Valve U-1. $\frac{1}{2}X$.

Fig. 29. Plunger from Valve U-23. 5X.

Fig. 30. Seat from Valve U-23. $\frac{1}{2}$ X.

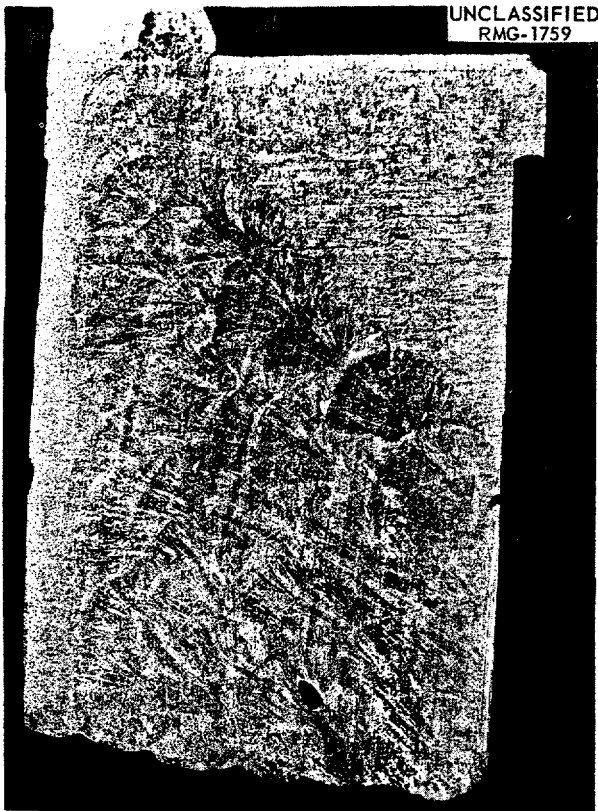
Metallographic examinations were completed of specimens R3, R7, R8, F5, F9, and S6.⁶ Specimen R8, a section from the pressure shell wall, including a weld, is shown in Fig. 31. A crack

Fig. 31. Section from ARE Pressure Shell, Including a Weld. 5X. (Secret with caption)
